# Manhole Inspection Summary

Manhole # S190\_\_012MH

Insp Date: **3/19/08 12:45 PM**

**Location** Address: **621 s bentalou st**

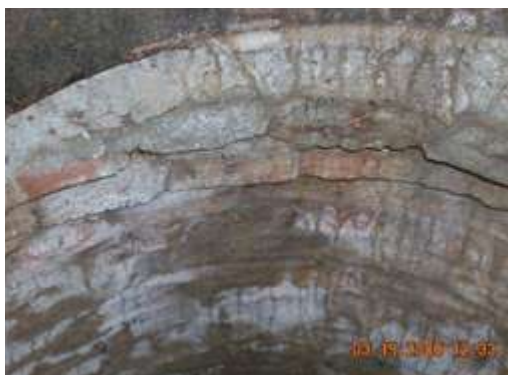
Defect 4

Infiltration: ☐ None ☒ **Joint** ☐ Cracks ☐ Mortar ☐ Roots ☒ **Wall**

infiltration at chimney/corbel joint

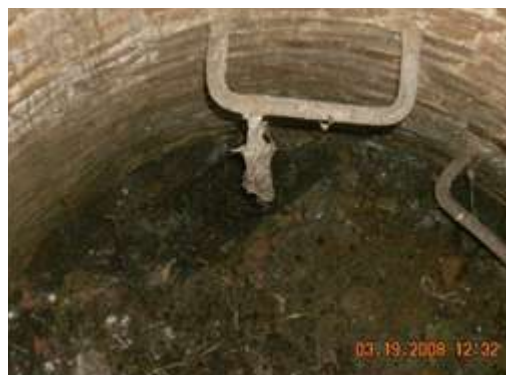
Defect 3

**Surcharge** ☒ **Evidence Of Surcharge** Depth: **4** (ft.) ☐ Active Surcharge Present

evidence of surcharge

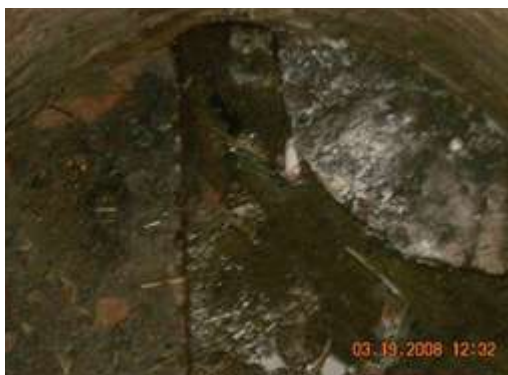
Defect 2

Condition: ☐ Sound ☐ Cracked ☐ Root Intrusion ☐ Deteriorated ☐ Leaks ☒ **Debris**

debris in channel

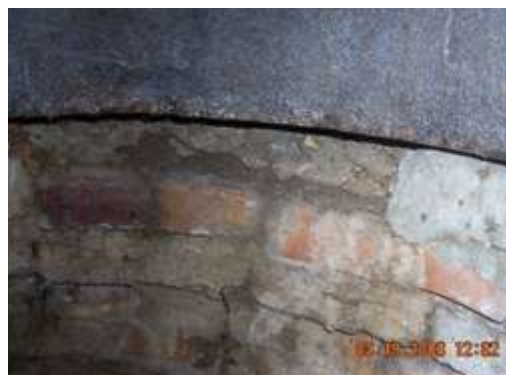
Defect 1

Condition: ☐ Sound ☐ Cracked ☐ Root Intrusion ☐ Loose Brick ☒ **Deteriorated**

deteriorated corbel

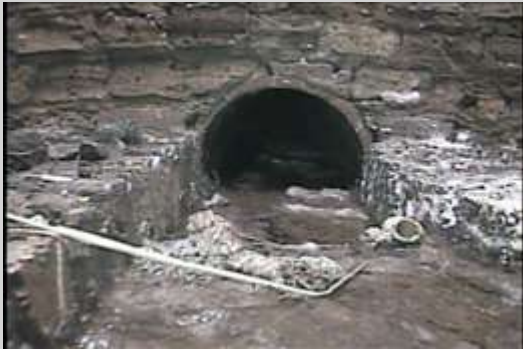
12 O'Clock Outflow

8 in. Circular Gravity Sewer  
Pipe Out @ 12 O'Clock

Pipe Height: **8.4** (in.) Rod and Bar (Angled)  
Pipe Material: **Clay** ☐ Pipe Lined  
Invert Depth: **6.13** (ft.) Flow Characteristics: **Slow**  
Deposits: ☐ None ☐ Mud ☒ **Sludge** ☒ **Debris** ☐ Grease  
Silt Depth: **3** (in.) Deposits Extent: **Medium**  
Infiltration: **None** Pipe Seal Cond: **Sound**

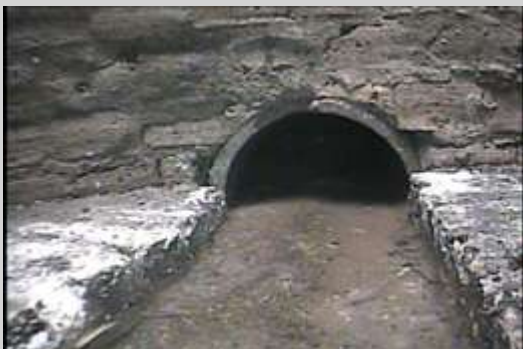
3 O'Clock Inflow

8 in. Circular Gravity Sewer  
Pipe In @ 3 O'Clock

Pipe Height: **8.4** (in.) Rod and Bar (Angled)  
Pipe Material: **Clay** ☐ Pipe Lined  
Invert Depth: **6.00** (ft.) Flow Characteristics: **Slow**  
Deposits: ☐ None ☐ Mud ☒ **Sludge** ☐ Debris ☐ Grease  
Silt Depth: **4** (in.) Deposits Extent: **Medium**  
Infiltration: **None** Pipe Seal Cond: **Broken**
